*Cruise Report
and preliminary results*

DUSTTRAFFIC: Transatlantic fluxes of Saharan dust

Cruise No. 64PE417

18 – 24 February 2017
Las Palmas de Gran Canaria (Spain) vv

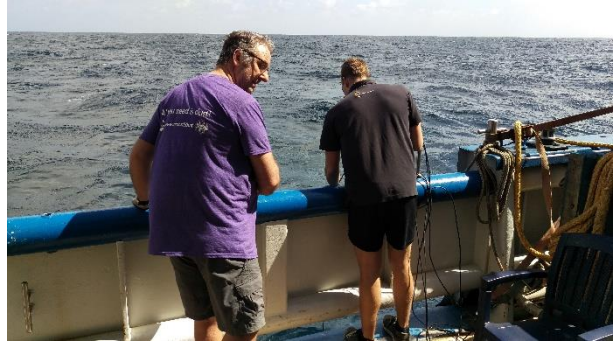
Pic. 4.2: Bob and Barry try to get in touch with the releasers through the hydrophone that's hung over the side of the ship

unit and releasers is most likely caused by noise from the engine room. For that reason, it is advised during future recoveries to contact the releasers from the far end of the aft deck.

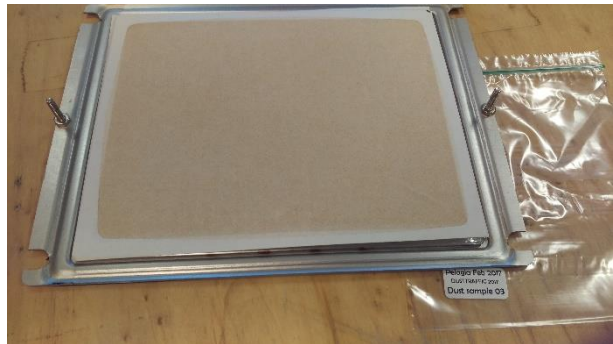
Pic. 4.6: Sample 3 has a very nice yield of dust

The dust collection that we are doing from the bridge contains a pilot study; we are collecting dust on acid-cleaned filters following the ultra-clean procedures that are necessary to measure dissolved iron in seawater. Dust is collected by two parallel HiQ dust collectors using Whatman 41 cellulose acetate filters. The first sample collected on 20 February has some slight greyish colouring. Sample number two, collected between 21 and 22 February has a little clearer orange-ish colouration. Sample number three, collected between 22 and 23 February has a very dust load as can be seen in the orange colouration.
